## Water Compliance Inspection Report

# **NPDES Inspection Report**

**Bel - Lyn Farms, LLC**

**March 29<sup>th</sup> and 30<sup>th</sup>, 2010**

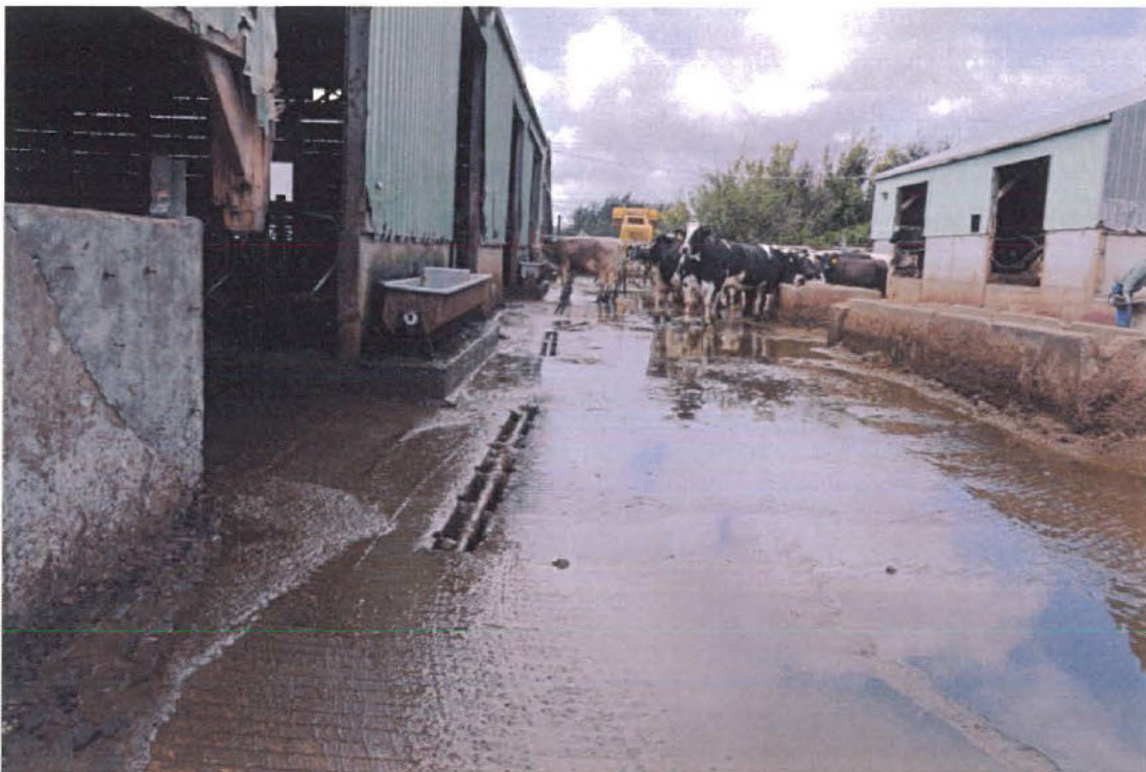
Photo 1. Bel-Lyn Dairy waste collection system in alley.

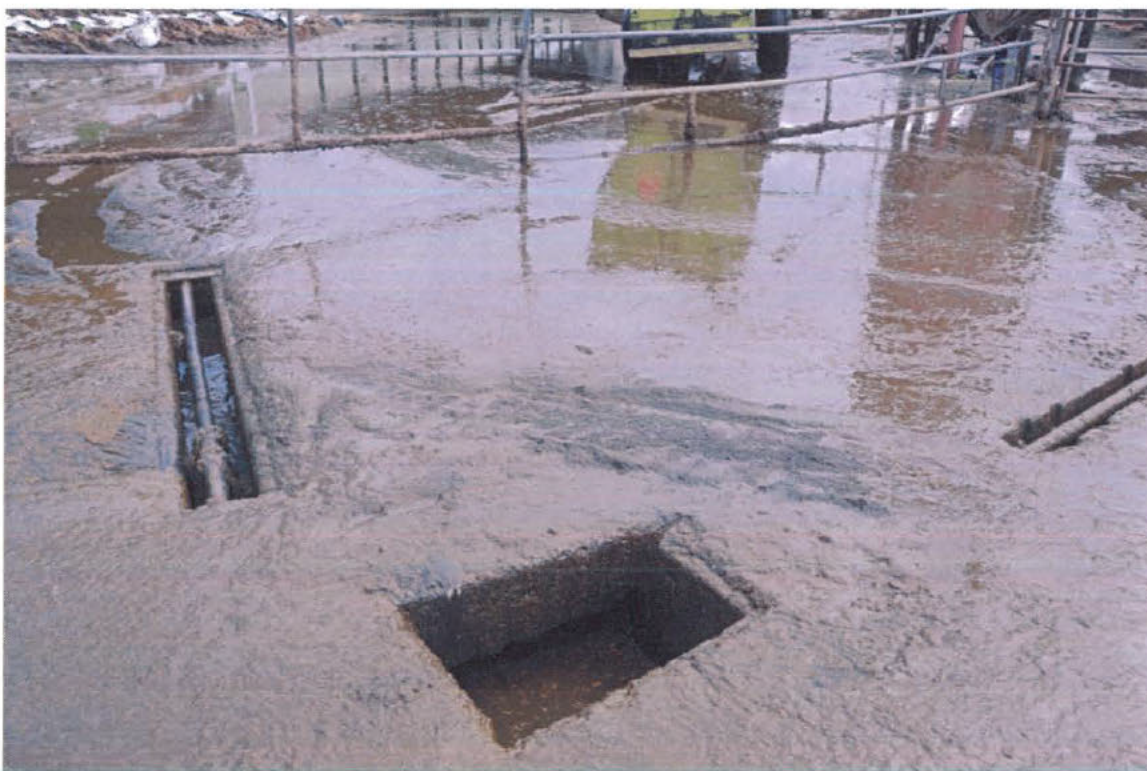
Photo 2. Bel-Lyn Dairy waste collection system showing an underground collection tank.

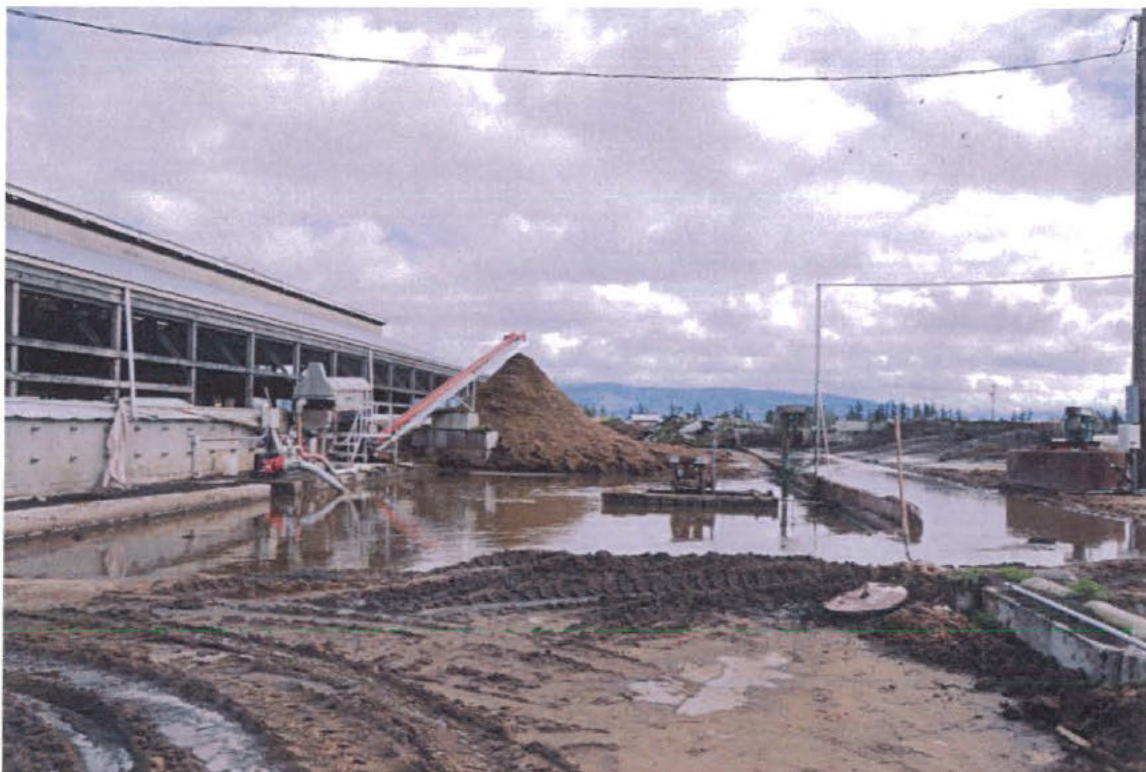
Photo 3. Bel-Lyn Dairy waste collection system with solid separator removing solids from open pit area.

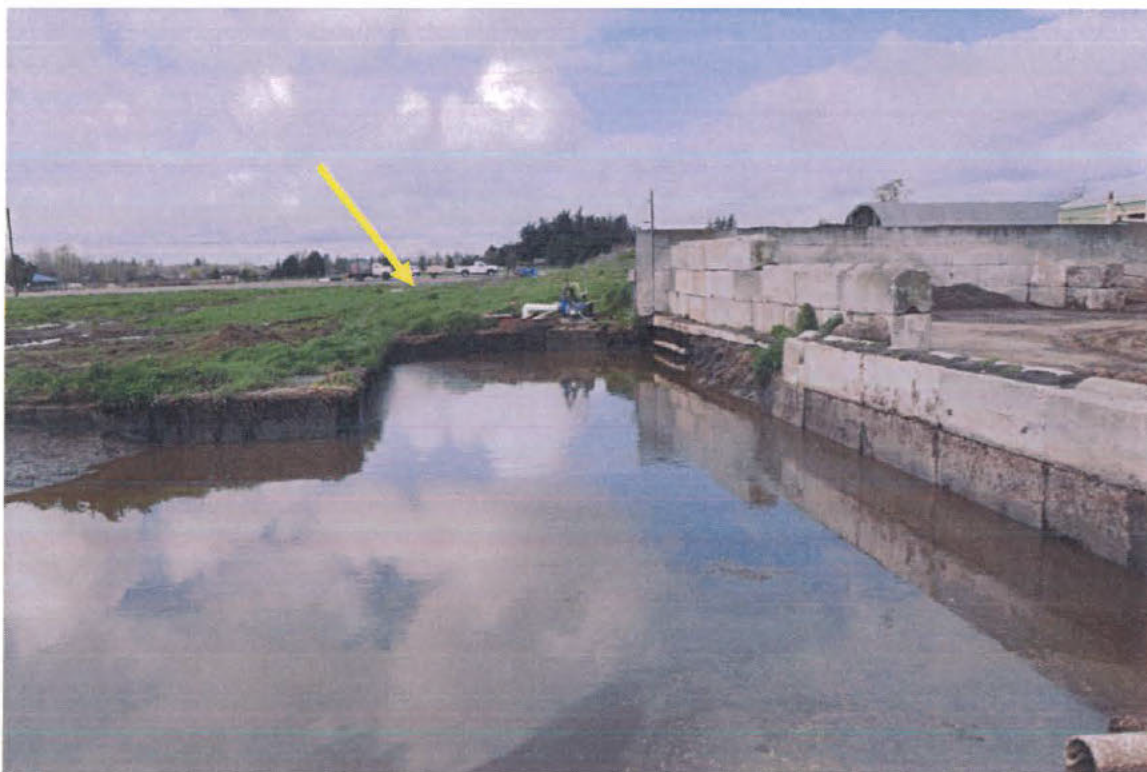
The Bel-Lyn Dairy is located at the intersection of Guide Meridian Road and Beard Road in Whatcom County. I saw a storm drain catch basin in the frontage road ditch. It appears the storm drain location is about 100 feet away from an old waste lagoon and next to a field where dairy waste (liquids and solids) are applied. The location of this storm drain has the potential to receive wastewater runoff from the dairy. At the time of the

inspection the storm drain was not receiving wastewater. See Attachment B, photographs number 4, 5, 6, 7 for location of storm drain.

This concern was an issue during a previous EPA inspection conducted at the dairy. During that inspection a discharge was occurring at the time of the inspection.

Photo 4. Bel-Lyn Dairy waste collection system looking west towards area where the storm drain is located. Yellow arrow points at storm drain along Guide Meridian Rd.

The closing conference was held on March 30, 2010. The individuals present were the inspection team members (Dave Terpening, Kristin McNeill, and Eric Blair) and Leroy Plagerman. During the closing conference I discussed the area of concern identified above. Mr. Plagerman, indicated that he had addressed that issued and corrected it, since the last inspection. Mr. Plagerman said the correction was moving a french drain system in the field that is adjacent to the storm drain.

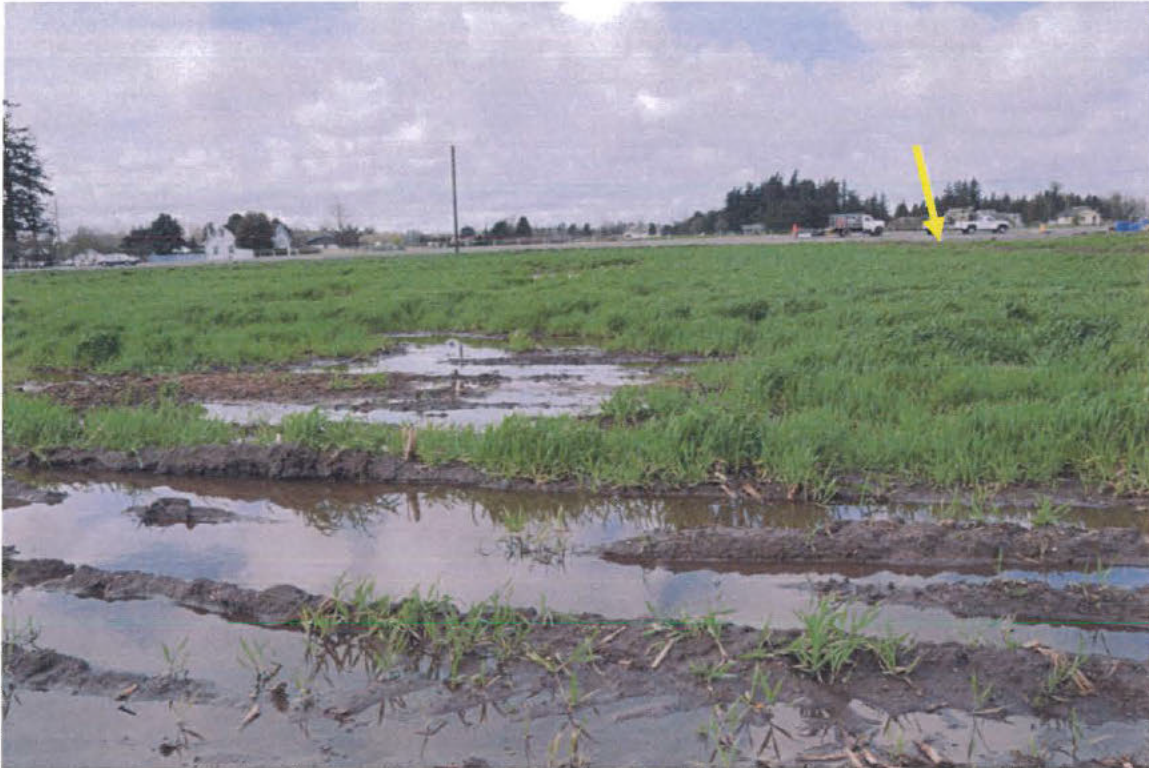
Photo 5. Bel-Lyn Dairy looking west across field adjacent to area where the storm drain is located. Yellow arrow points at storm drain along Guide Meridian Rd.

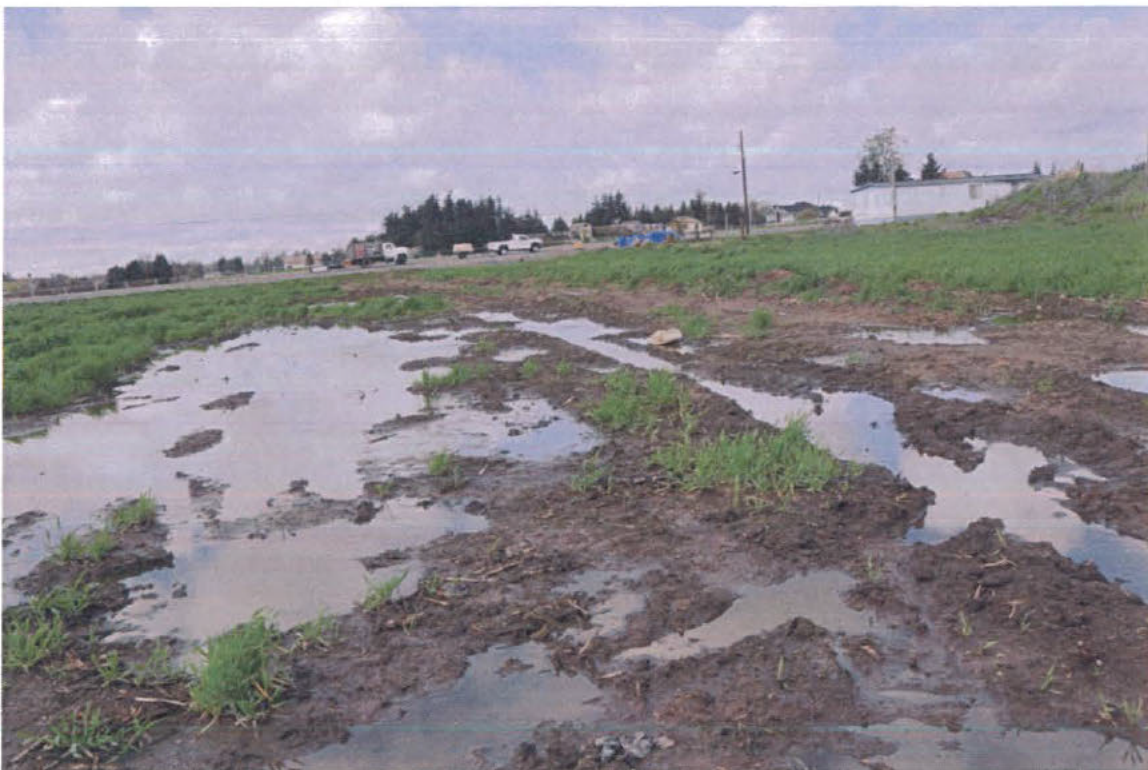
Photo 6. Bel-Lyn Dairy looking west across field adjacent to area where the storm drain is located. Yellow arrow points at storm drain along Guide Meridian Rd.

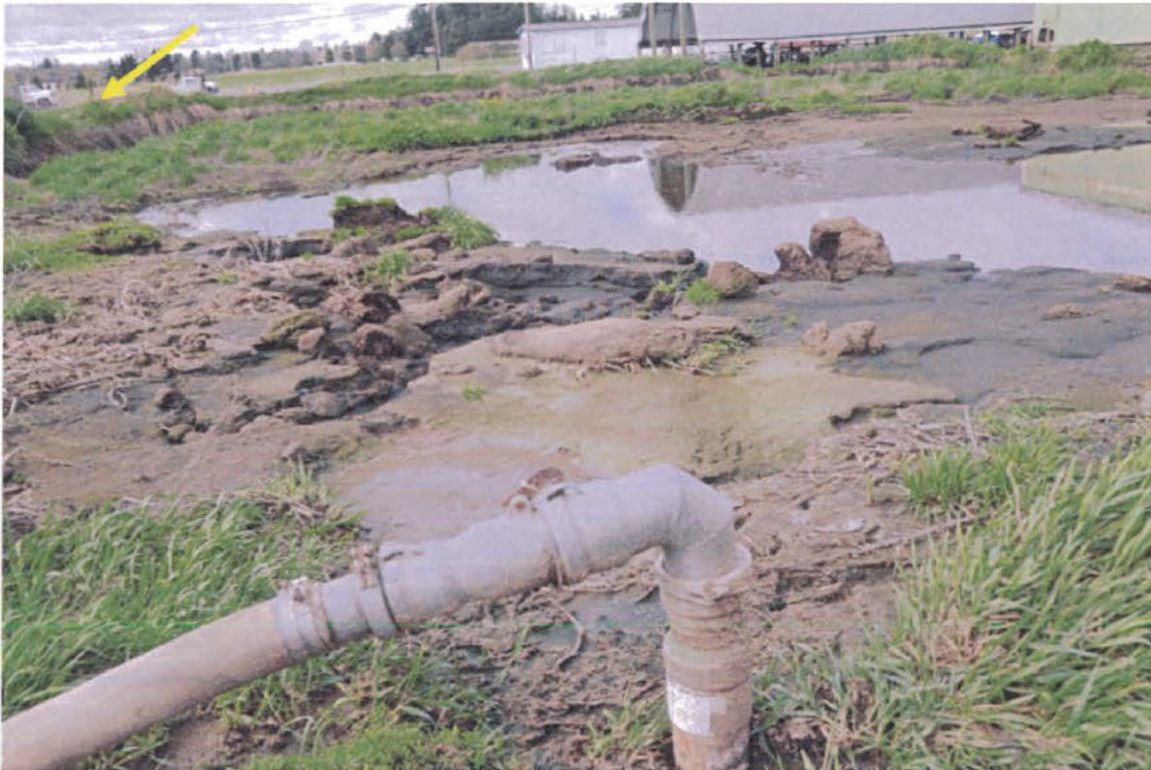
Photo 7. Bel-Lyn Dairy looking west across old storage lagoon near the area where the storm drain is located. Yellow arrow points at storm drain along Guide Meridian Rd.

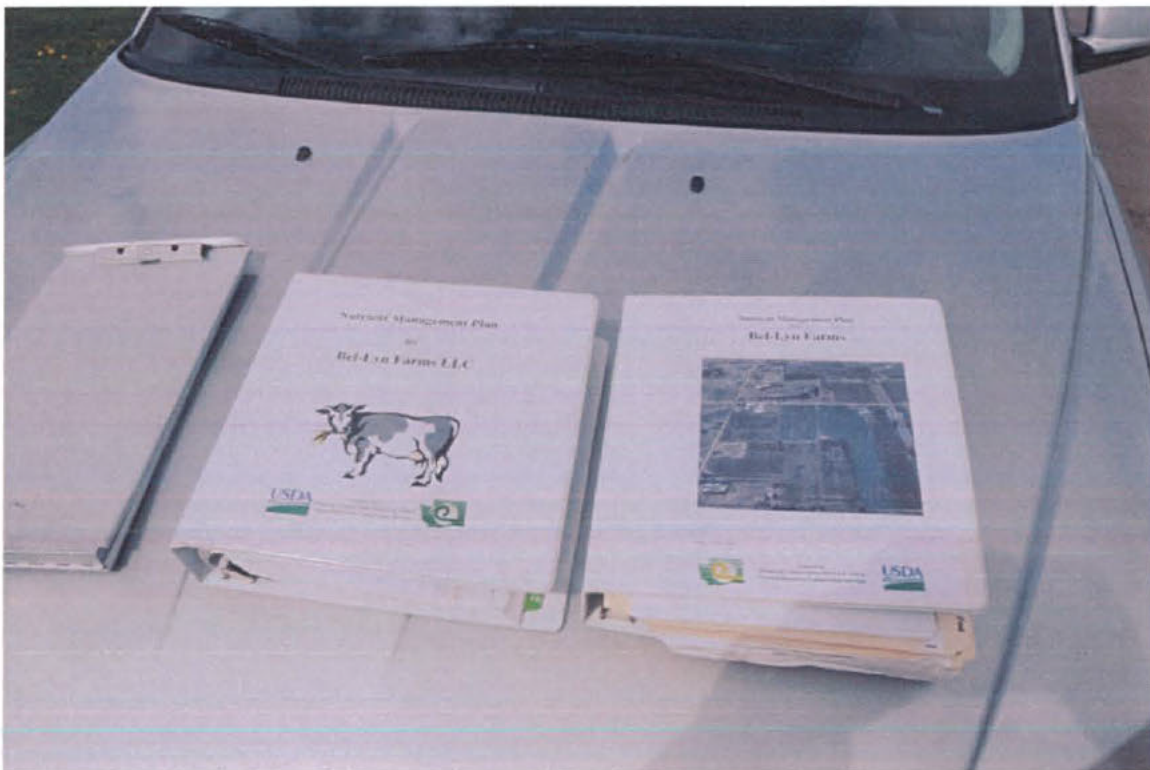
Photo 8. Bel-Lyn Dairy nutrient management plan.
